ODT-Spruce Railroad Trail Final Phase Progress Report (March – April, 2020)

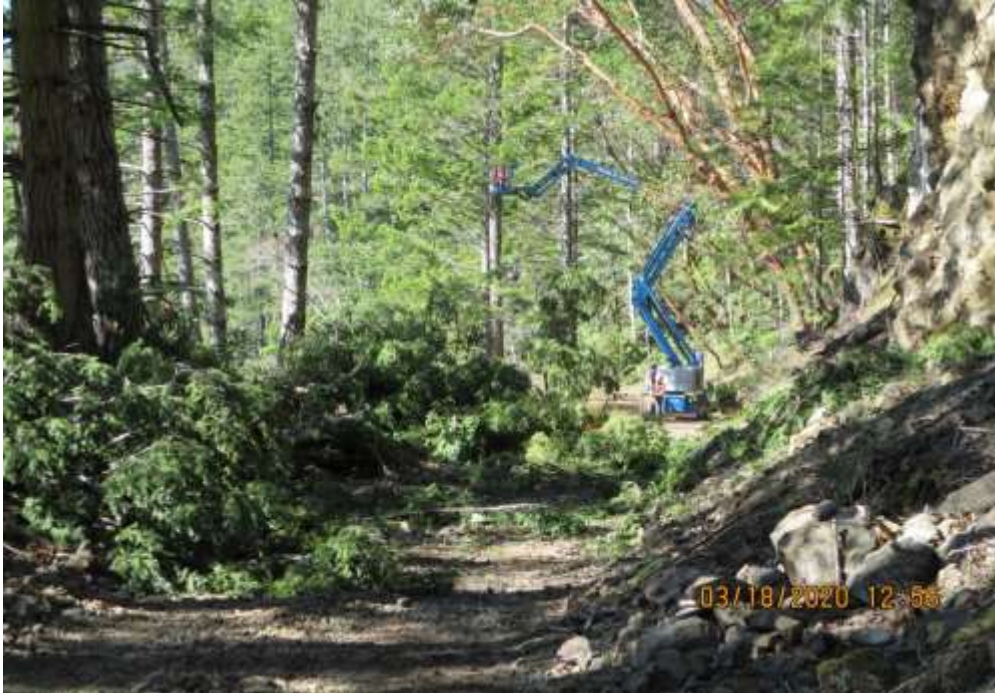
March 16 - 20:

- Contractor initiated mobilizing equipment to project site.
- Began tree removal process.

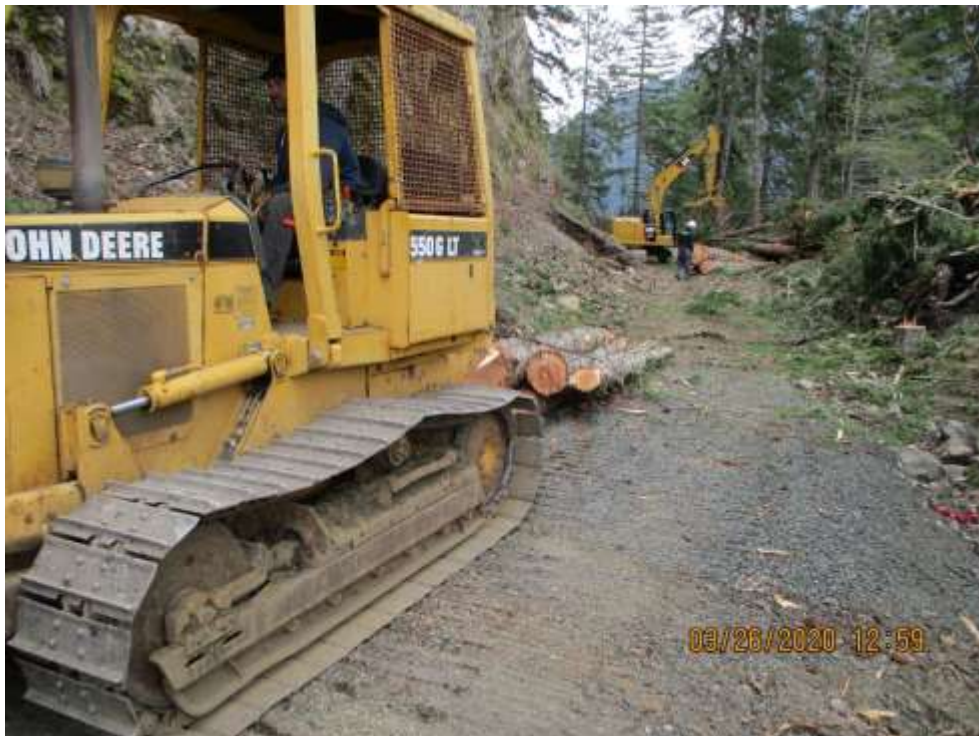
March 23 – 27

- Completed tree felling process.
- Work on removal of all tree limbs and brush on west end of project area.

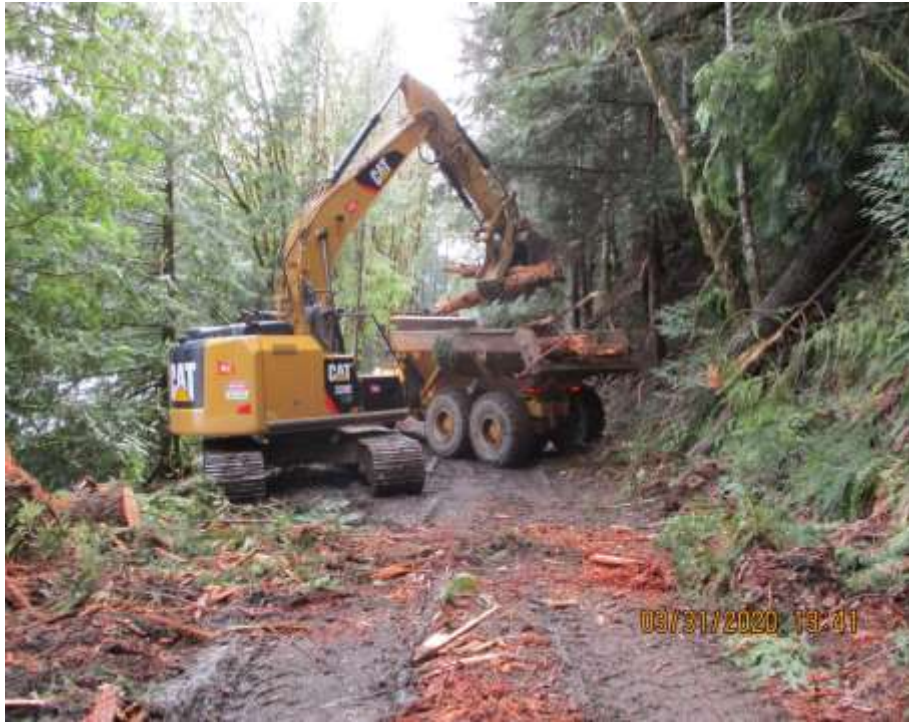
March 30 – April 3

- Continue clearing and grubbing process.
- Continue transport of logs to the Lyre River parking to be hauled off-site.

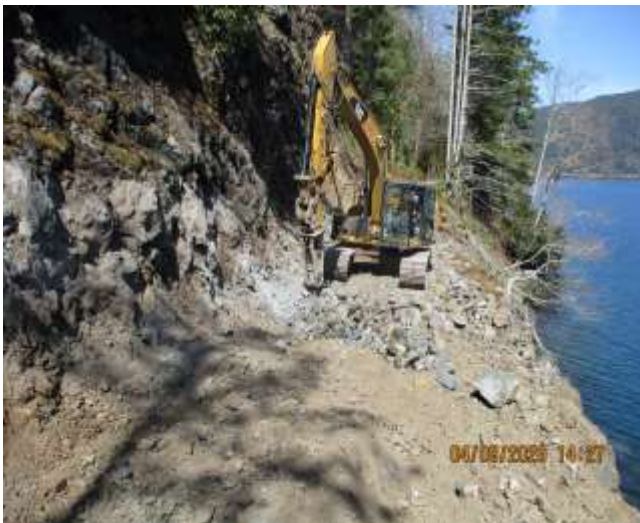
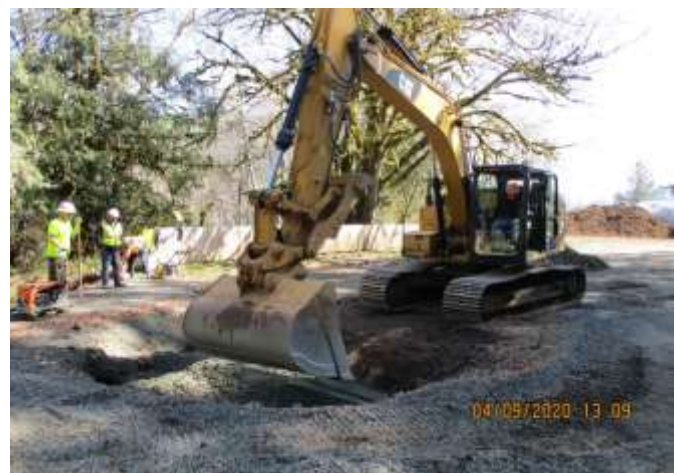
April 6 – April 10

- The Contractor started excavation for one of the Mechanically Stabilized Earth (MSE) walls that will be constructed in between the tunnels. A rock breaker has to be utilized to remove some of the bedrock to create a foundation for the wall to be set on.
- Contractor placed a culvert pipe in the hole that existed in the Spruce Railroad Trail head parking lot. The hole was filled and leveled to prepare it for paving at the end of summer.

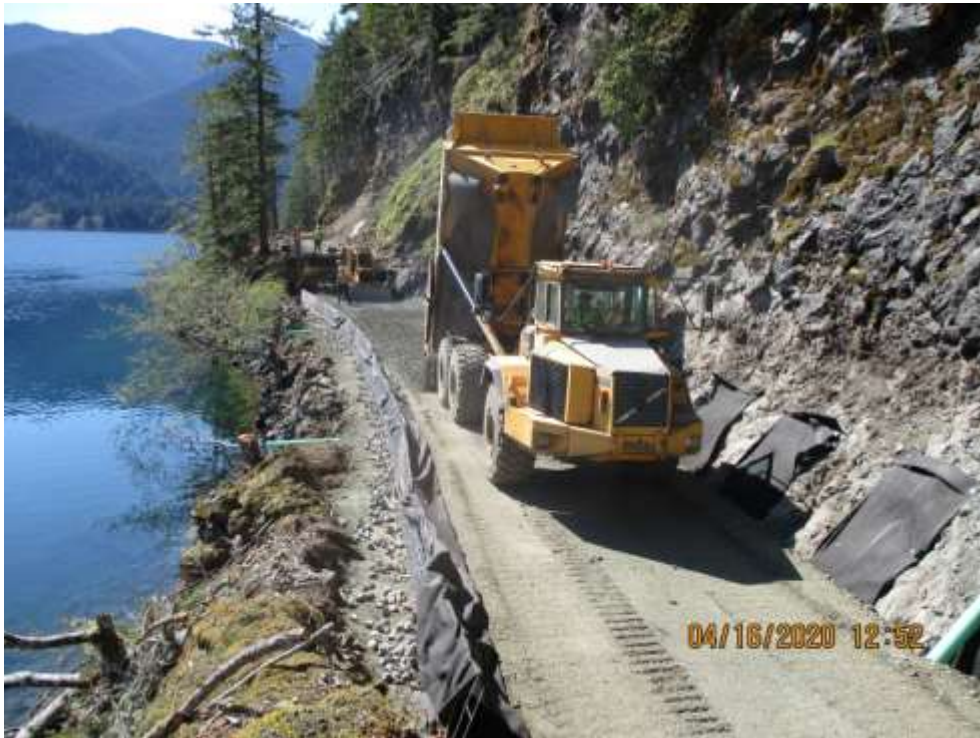
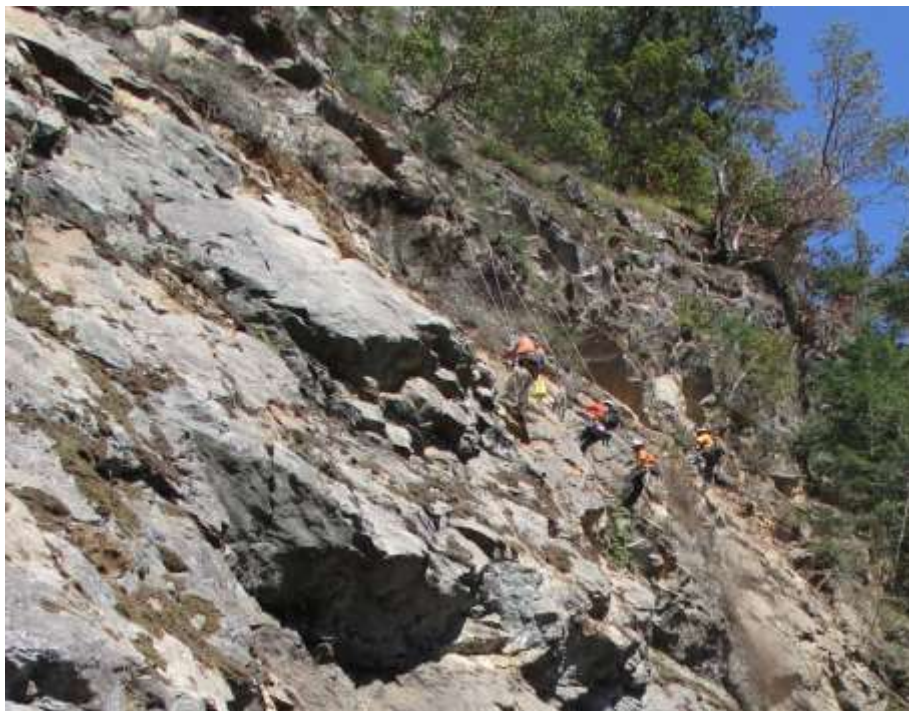
April 13 -17

- Sub-contractor started removal of loose rock from the slope on the west-side of the Daley-Rankin tunnel. This is the preliminary work that will be done before they start inserting the rock bolts.
- Contractor is building one of the six Mechanically Stabilized Earth walls. The wall being constructed is approximately 3,500 feet west of the Mc Fee Tunnel. The wall backfill material is stored in the parking lot at the Spruce Railroad trailhead and the Lyre River, and they are transporting the backfill material into the wall site with large off road dump trucks.

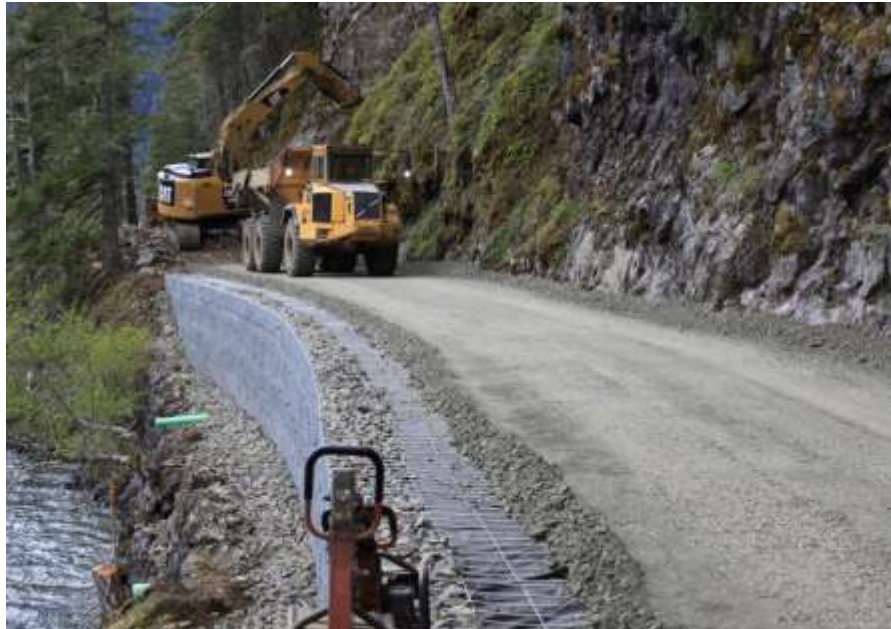
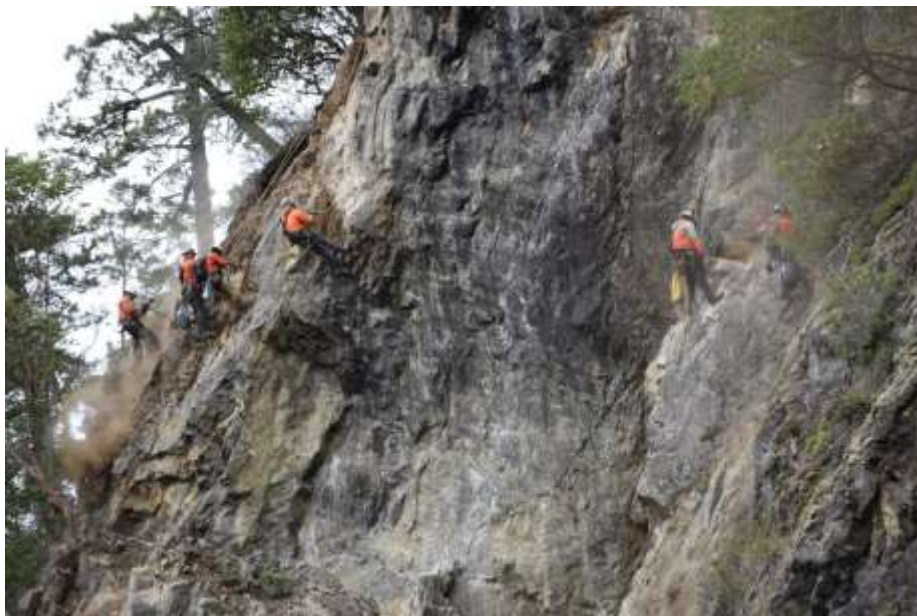
April 20 – 24

- Contractor completed one of the six Mechanically Stabilized Earth (MSE) wall.
- Contractors are now establishing a road to gain access to the next MSE wall to begin excavation and construction.
- Sub-contractor has been scaling rock from the rock face on the west-side of the Daley-Rankin Tunnel. Removal of the rock on the west-side is nearly complete and work will advance to the east-side of the tunnel. This work will take approximately two weeks to complete.
